REMOVAL REPORT
FOR
DIAZ INTERMEDIATES CORPORATION SITE
301 WYANOKE ROAD
WEST MEMPHIS, CRITTENDEN COUNTY, ARKANSAS

**REMOVAL ASSESSMENT REPORT
FOR
DIAZ INTERMEDIATES CORPORATION SITE

301 WYANOKE ROAD
WEST MEMPHIS, CRITTENDEN COUNTY, ARKANSAS**

Date Prepared:
October 27, 2008

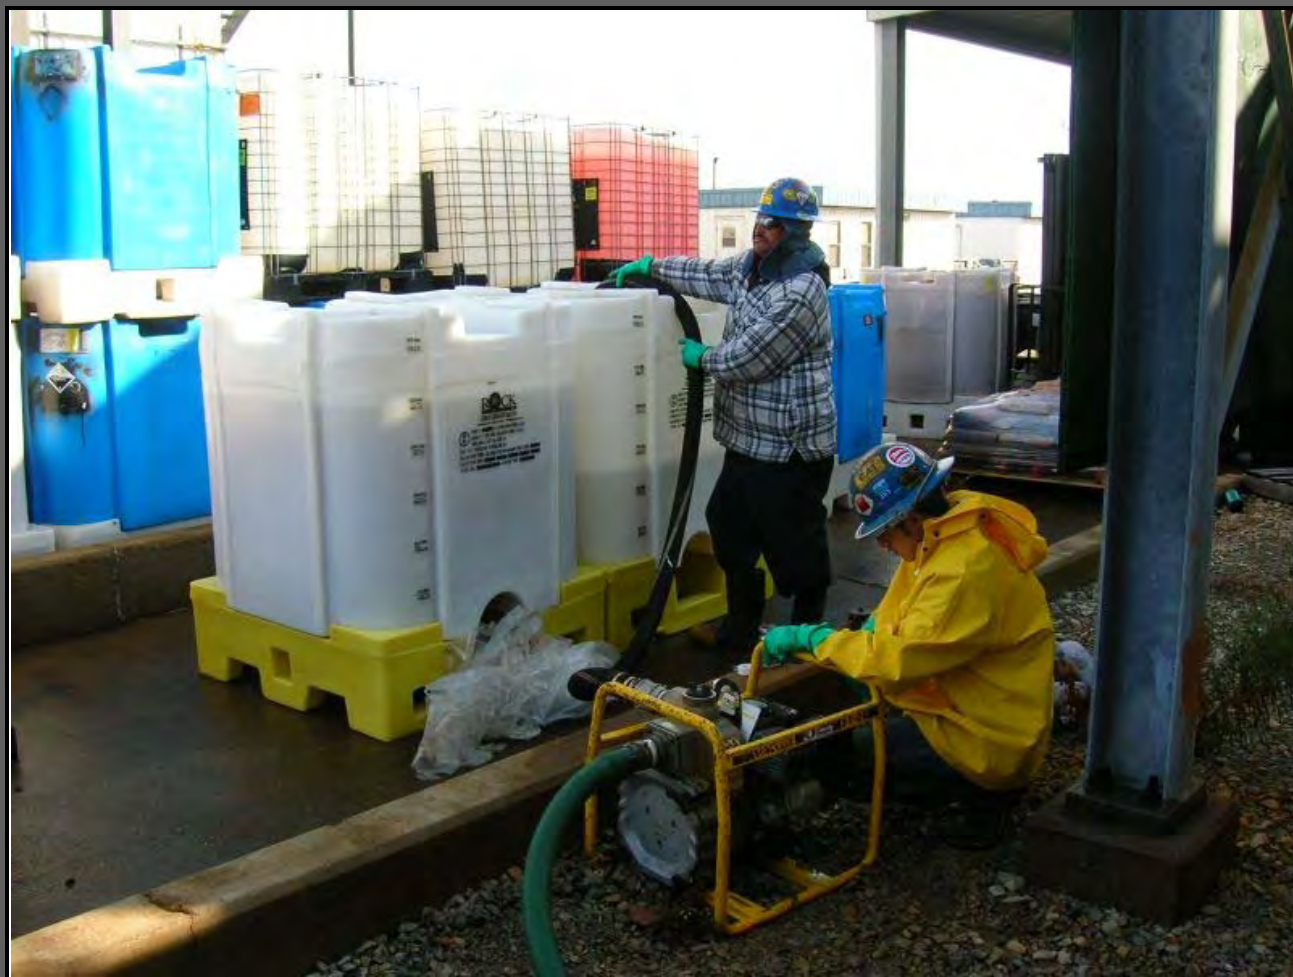
Logbook Photo #	050
US EPA ID / Task Order Number	ARR000005843 / TO-0001-08-01-01
Site	Diaz Intermediates Corporation
Location Address	301 Wyanoke Road
City, State, ZIP code	West Memphis, Arkansas 72301
County	Crittenden
Direction/Orientation	Southwest
Date	01/29/08
Time	1450
Photographer	Troy Naquin, Dynamac START-3
Witness	Charles Fisher, EPA Region 6
Description: Pumping storm water from the Old Tank Farm secondary containment area into tote tanks for mixing with caustic soda.

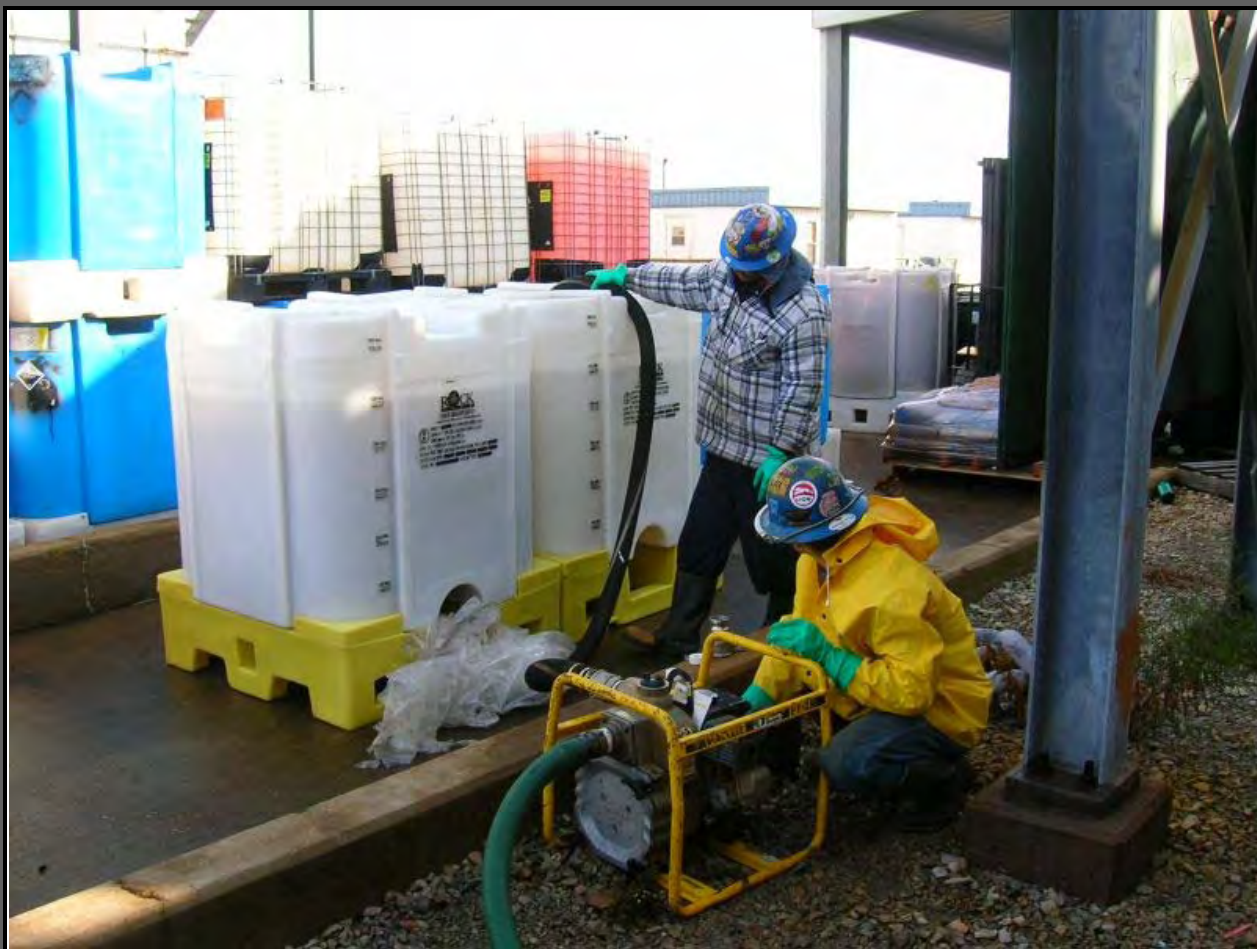
Logbook Photo #	051
US EPA ID / Task Order Number	ARR000005843 / TO-0001-08-01-01
Site	Diaz Intermediates Corporation
Location Address	301 Wyanoke Road
City, State, ZIP code	West Memphis, Arkansas 72301
County	Crittenden
Direction/Orientation	Southeast
Date	01/29/08
Time	1450
Photographer	Troy Naquin, Dynamac START-3
Witness	Charles Fisher, EPA Region 6
Description: Pumping storm water from the Old Tank Farm secondary containment area into tote tanks for mixing with caustic soda.

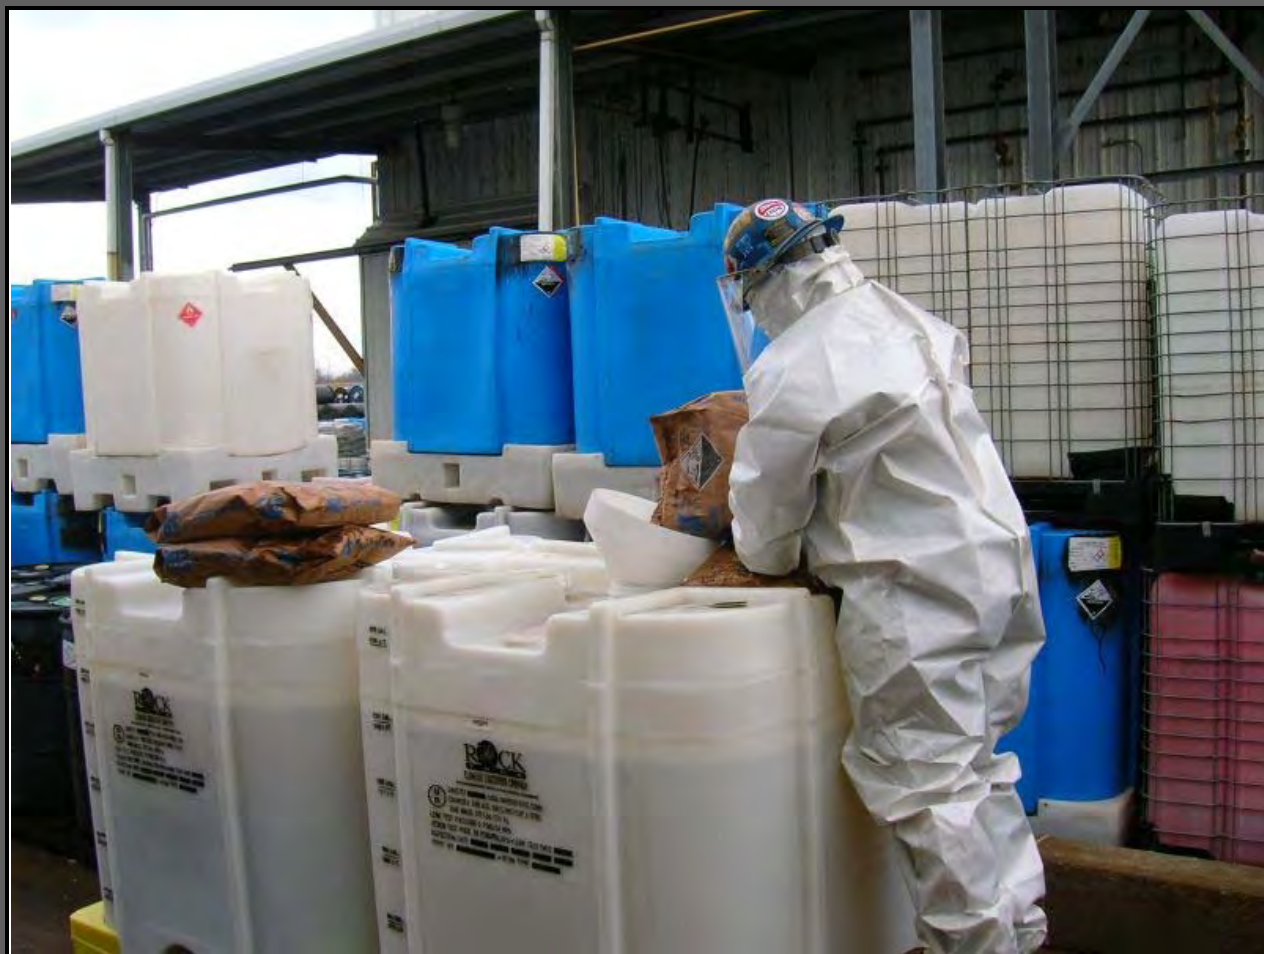
Logbook Photo #	052
US EPA ID / Task Order Number	ARR000005843 / TO-0001-08-01-01
Site	Diaz Intermediates Corporation
Location Address	301 Wyanoke Road
City, State, ZIP code	West Memphis, Arkansas 72301
County	Crittenden
Direction/Orientation	Southeast
Date	01/29/08
Time	1451
Photographer	Troy Naquin, Dynamac START-3
Witness	Charles Fisher, EPA Region 6
Description: Pumping storm water from the Old Tank Farm secondary containment area into tote tanks for mixing with caustic soda.

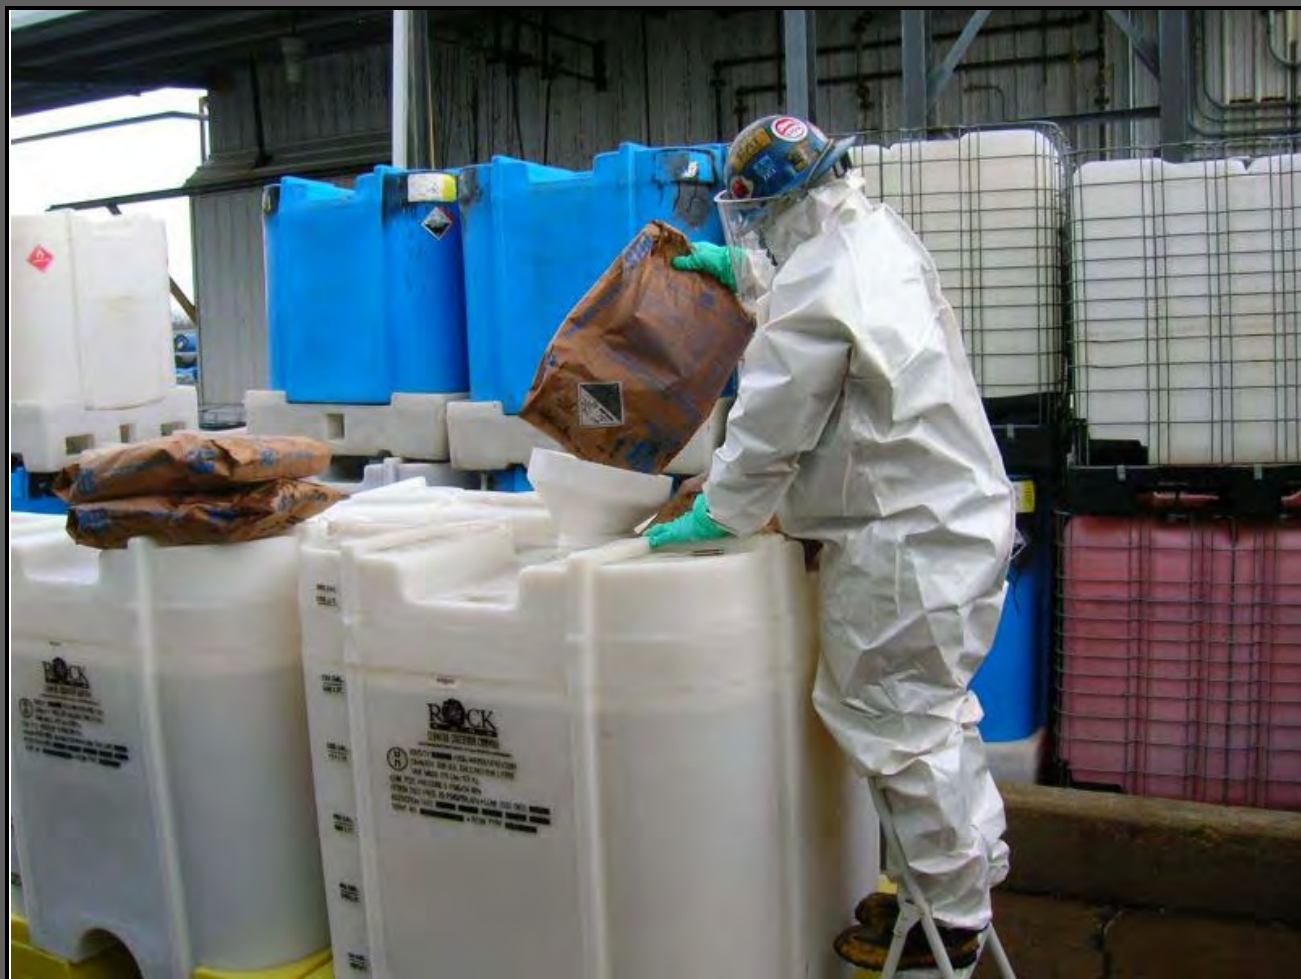
Logbook Photo #	053
US EPA ID / Task Order Number	ARR000005843 / TO-0001-08-01-01
Site	Diaz Intermediates Corporation
Location Address	301 Wyanoke Road
City, State, ZIP code	West Memphis, Arkansas 72301
County	Crittenden
Direction/Orientation	Northeast
Date	01/29/08
Time	1501
Photographer	Troy Naquin, Dynamac START-3
Witness	Charles Fisher, EPA Region 6
Description: Adding caustic soda into tote tank containing storm water from the Old Tank Farm secondary containment area.

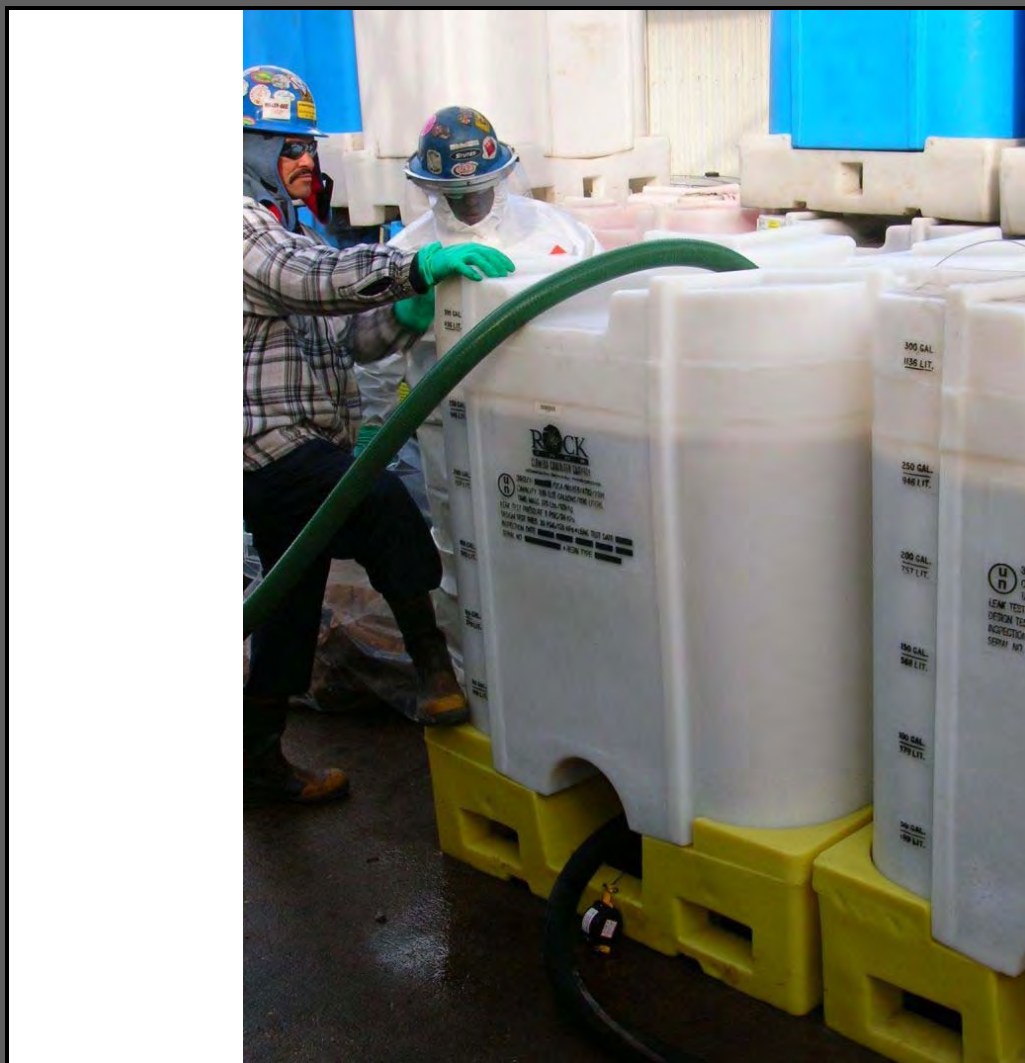
Logbook Photo #	054
US EPA ID / Task Order Number	ARR000005843 / TO-0001-08-01-01
Site	Diaz Intermediates Corporation
Location Address	301 Wyanoke Road
City, State, ZIP code	West Memphis, Arkansas 72301
County	Crittenden
Direction/Orientation	Northeast
Date	01/29/08
Time	1503
Photographer	Troy Naquin, Dynamac START-3
Witness	Charles Fisher, EPA Region 6
Description: Adding caustic soda into tote tank containing storm water from the Old Tank Farm secondary containment area.

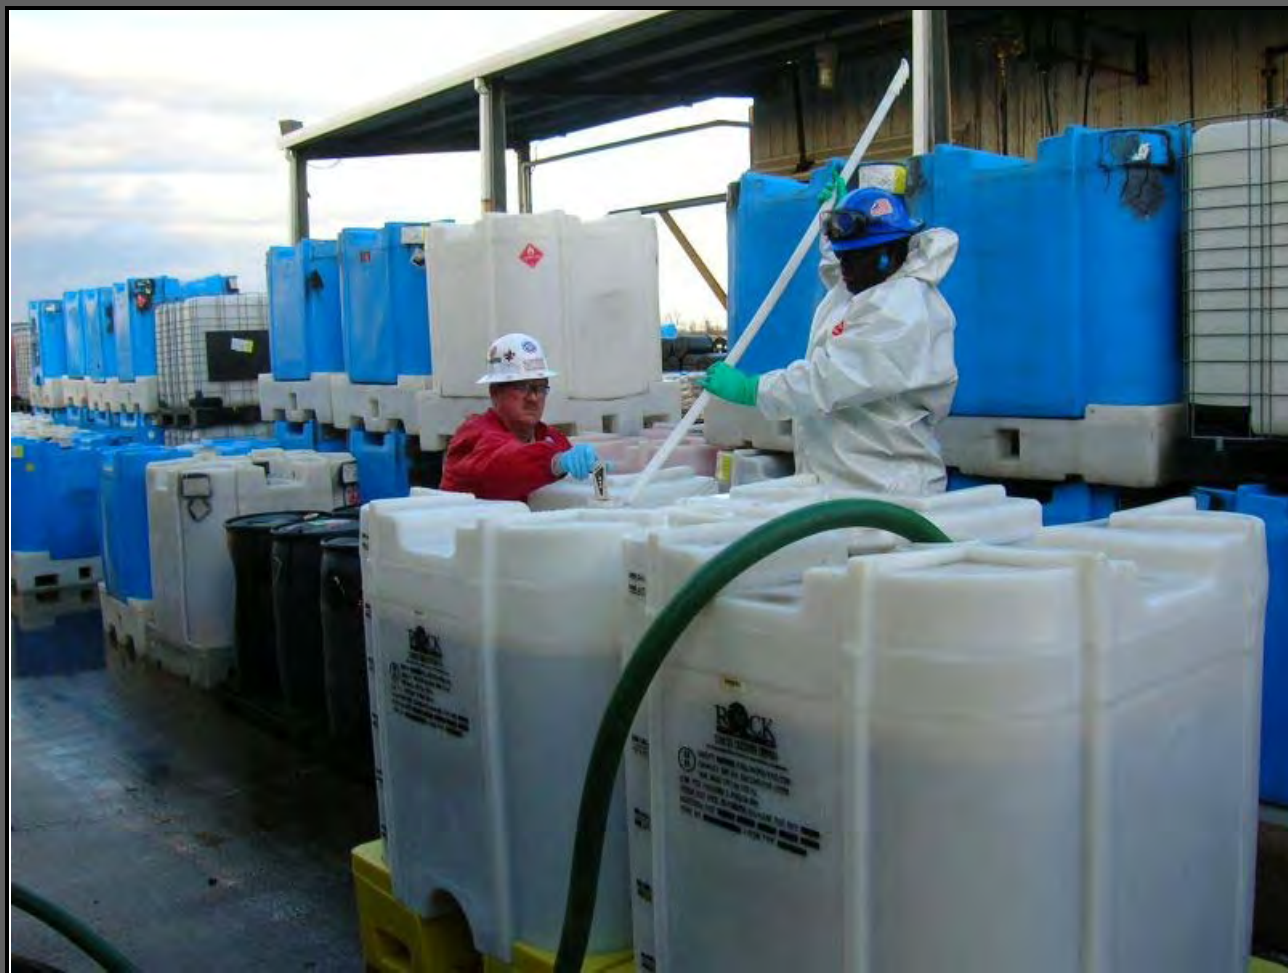
Logbook Photo #	055
US EPA ID / Task Order Number	ARR000005843 / TO-0001-08-01-01
Site	Diaz Intermediates Corporation
Location Address	301 Wyanoke Road
City, State, ZIP code	West Memphis, Arkansas 72301
County	Crittenden
Direction/Orientation	Northeast
Date	01/29/08
Time	1512
Photographer	Troy Naquin, Dynamac START-3
Witness	Charles Fisher, EPA Region 6
Description: Circulating caustic soda with storm water from the Old Tank Farm secondary containment area.

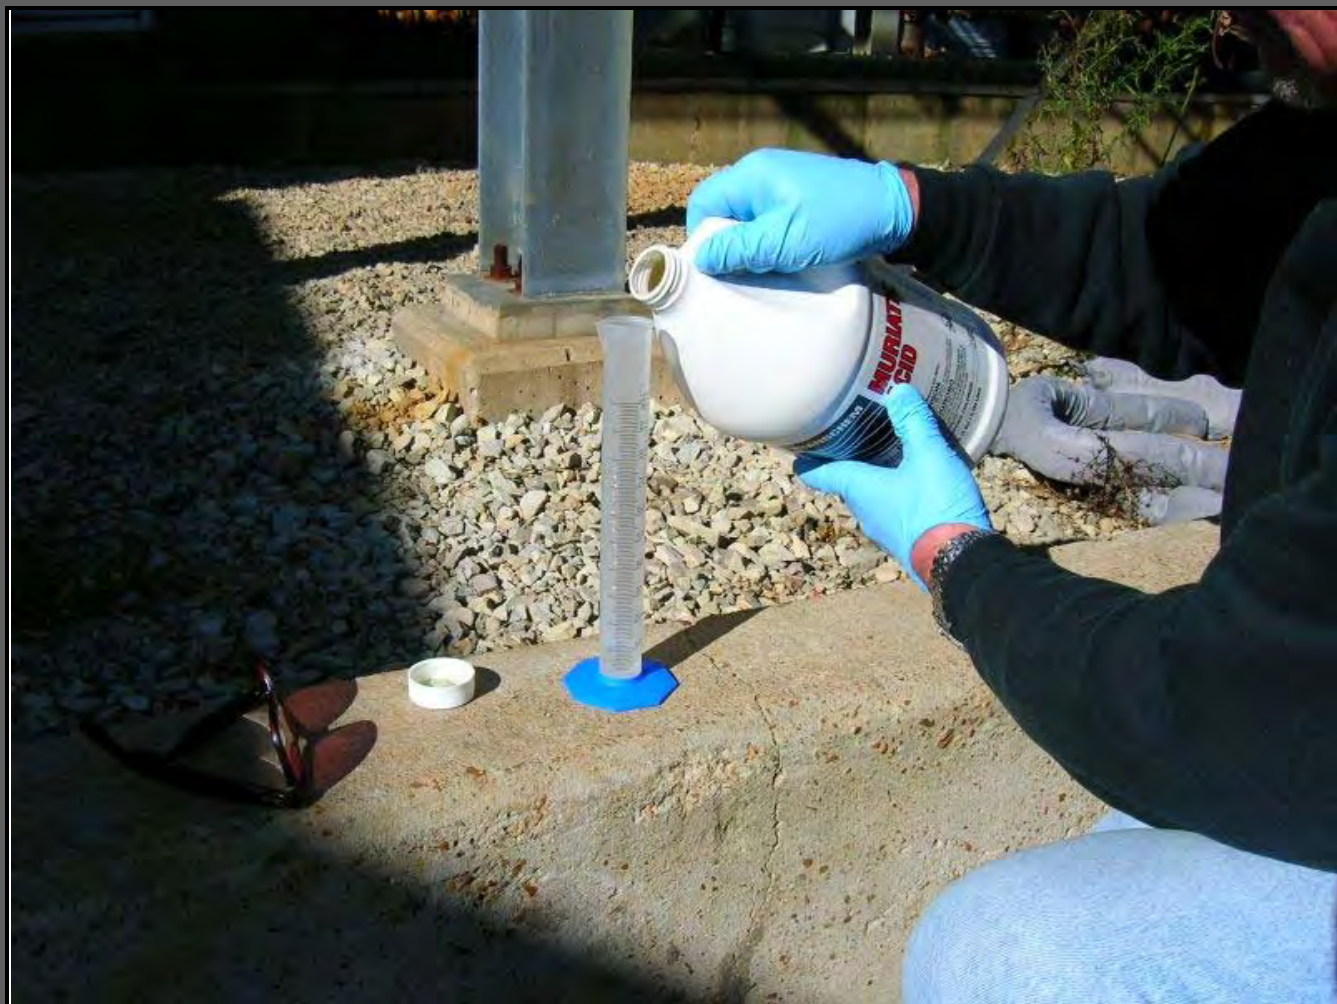
Logbook Photo #	060
US EPA ID / Task Order Number	ARR000005843 / TO-0001-08-01-01
Site	Diaz Intermediates Corporation
Location Address	301 Wyanoke Road
City, State, ZIP code	West Memphis, Arkansas 72301
County	Crittenden
Direction/Orientation	West-Northwest
Date	01/30/08
Time	1034
Photographer	Troy Naquin, Dynamac START-3
Witness	Charles Fisher, EPA Region 6
Description: Measuring an amount of muriatic acid to add to the tote tank with storm water from the Old Tank Farm secondary containment area to raise pH and precipitate out zinc.

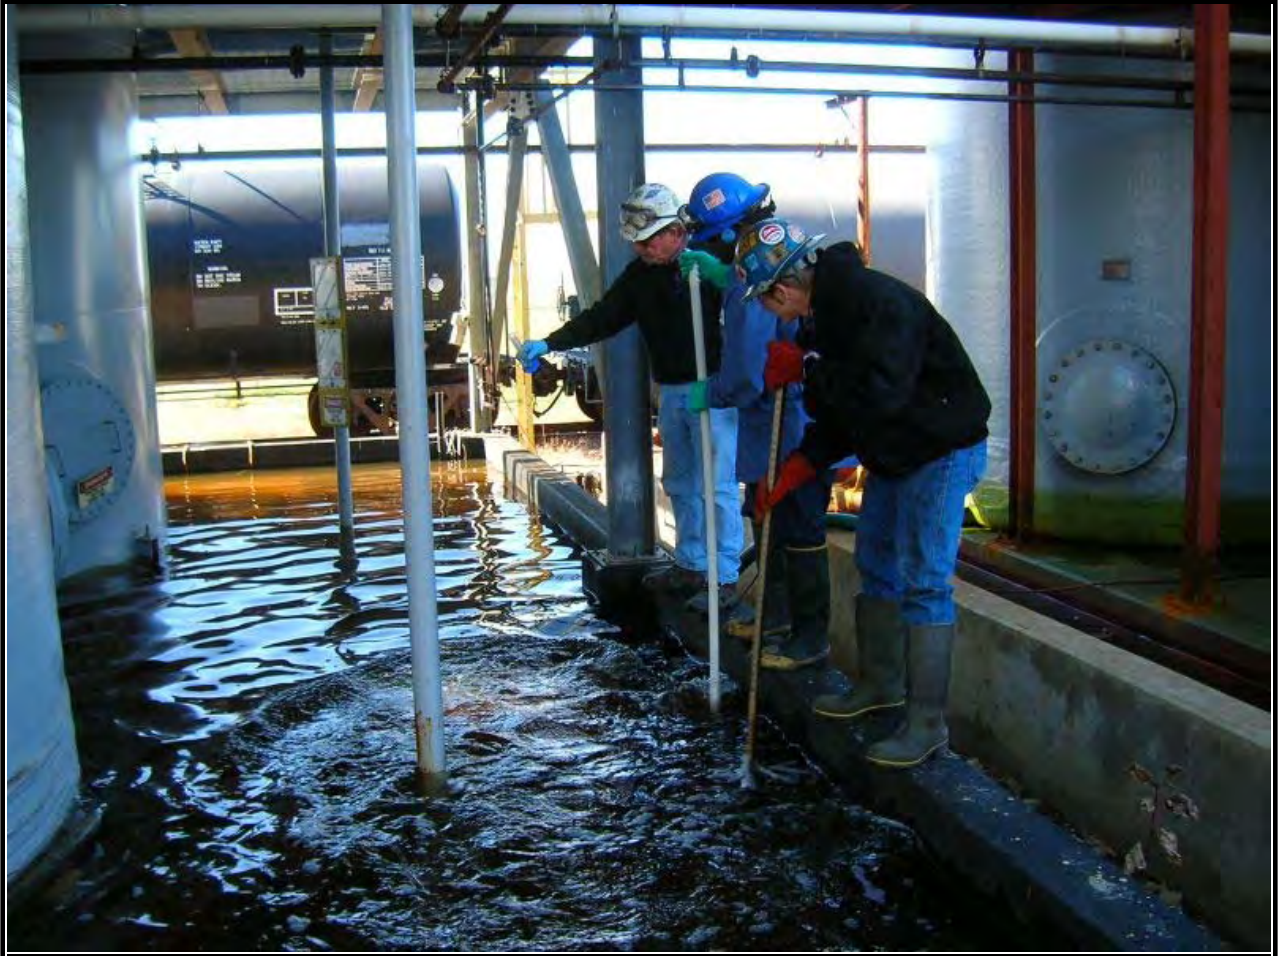
Logbook Photo #	064
US EPA ID / Task Order Number	ARR000005843 / TO-0001-08-01-01
Site	Diaz Intermediates Corporation
Location Address	301 Wyanoke Road
City, State, ZIP code	West Memphis, Arkansas 72301
County	Crittenden
Direction/Orientation	West-Northwest
Date	01/30/08
Time	1322
Photographer	Troy Naquin, Dynamac START-3
Witness	Charles Fisher, EPA Region 6
Description: ERRS adding and mixing muriatic acid to the pooled storm water in the Old Tank Farm secondary containment area to raise pH and precipitate zinc.

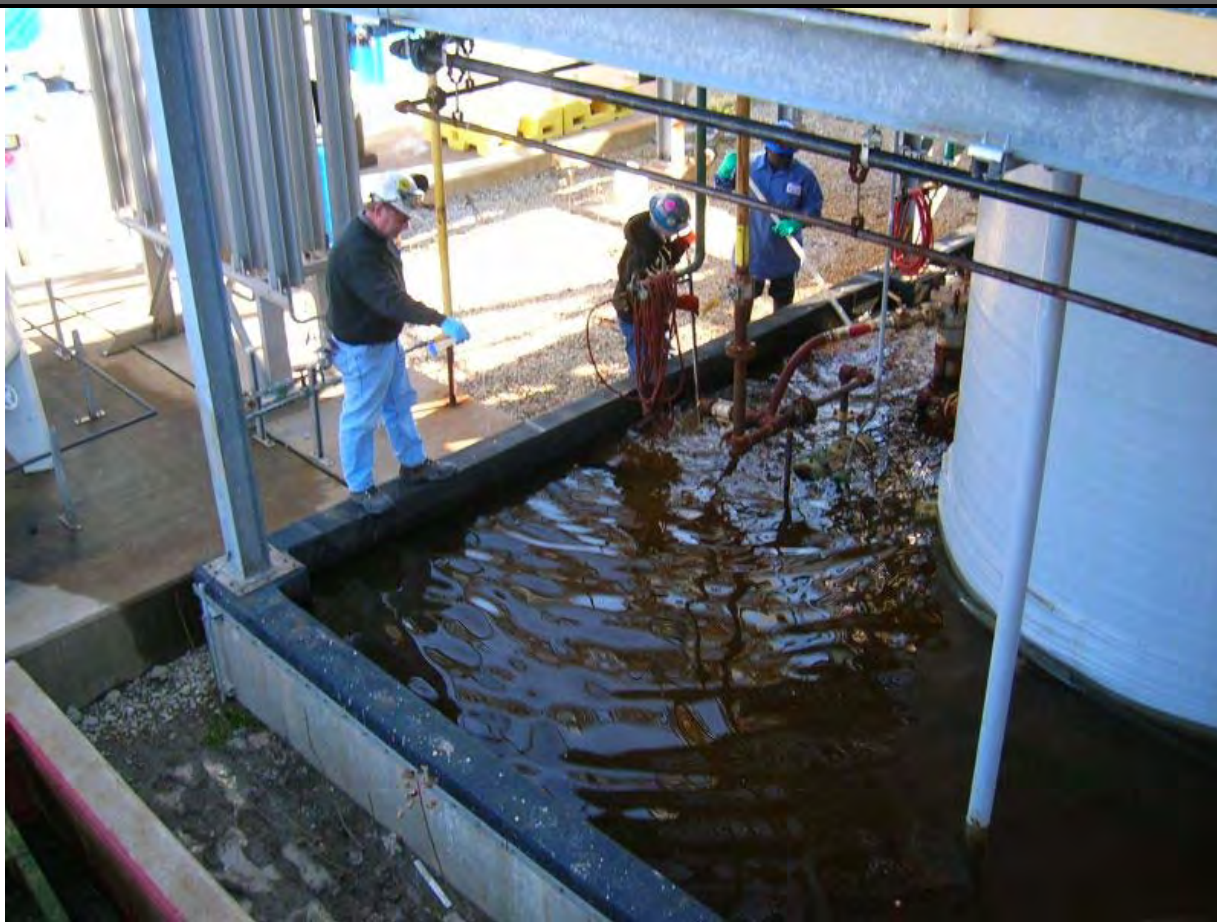
Logbook Photo #	065
US EPA ID / Task Order Number	ARR000005843 / TO-0001-08-01-01
Site	Diaz Intermediates Corporation
Location Address	301 Wyanoke Road
City, State, ZIP code	West Memphis, Arkansas 72301
County	Crittenden
Direction/Orientation	Down
Date	01/30/08
Time	1326
Photographer	Troy Naquin, Dynamac START-3
Witness	Charles Fisher, EPA Region 6
Description: ERRS adding and mixing muriatic acid to the pooled storm water in the Old Tank Farm secondary containment area to raise pH and precipitate zinc.

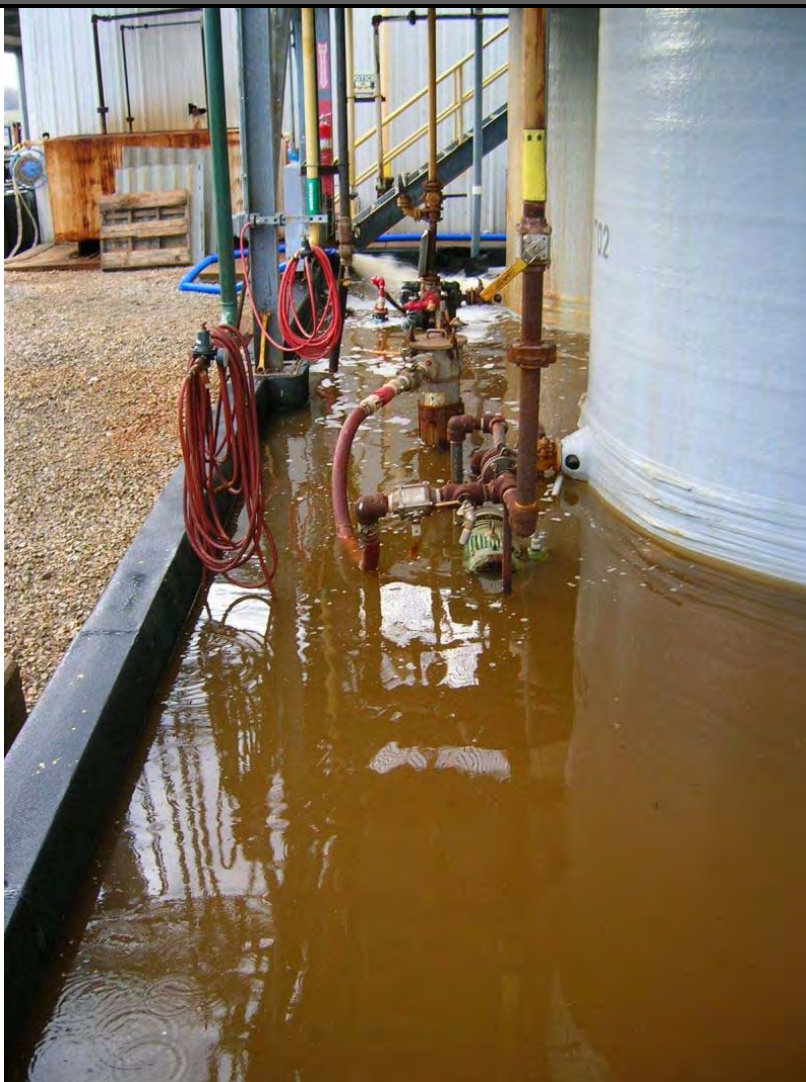
Logbook Photo #	066
US EPA ID / Task Order Number	ARR000005843 / TO-0001-08-01-01
Site	Diaz Intermediates Corporation
Location Address	301 Wyanoke Road
City, State, ZIP code	West Memphis, Arkansas 72301
County	Crittenden
Direction/Orientation	South
Date	01/31/08
Time	0813
Photographer	Troy Naquin, Dynamac START-3
Witness	Charles Fisher, EPA Region 6
Description: Mixing pooled storm water in Old Tank Farm secondary containment area treated with muriatic acid.

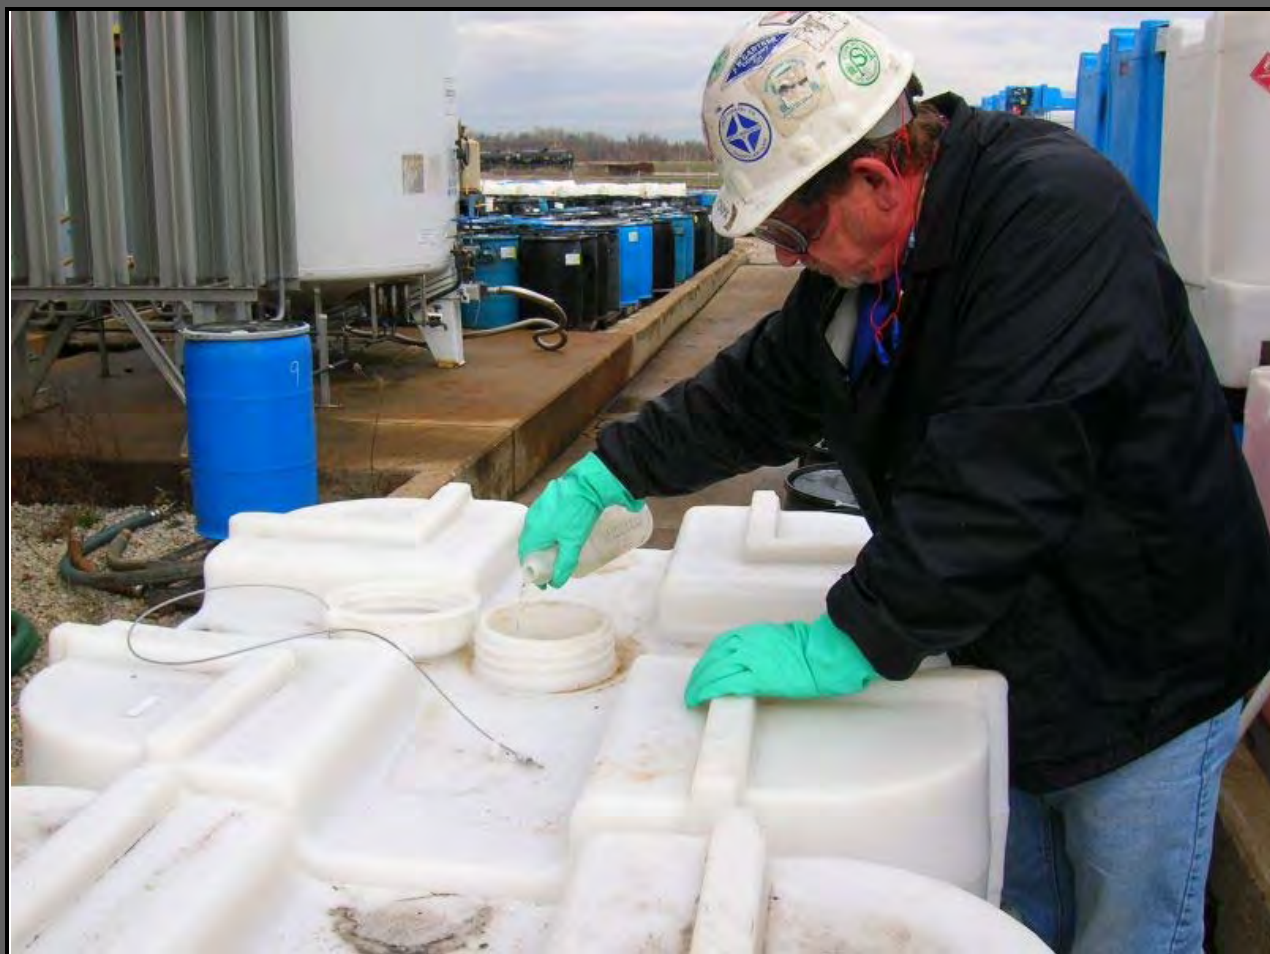
Logbook Photo #	067
US EPA ID / Task Order Number	ARR000005843 / TO-0001-08-01-01
Site	Diaz Intermediates Corporation
Location Address	301 Wyanoke Road
City, State, ZIP code	West Memphis, Arkansas 72301
County	Crittenden
Direction/Orientation	North
Date	01/31/08
Time	0837
Photographer	Troy Naquin, Dynamac START-3
Witness	Charles Fisher, EPA Region 6
Description: Adding muriatic acid to the tote tank with storm water from the Old Tank Farm secondary containment area to raise pH and precipitate out zinc.

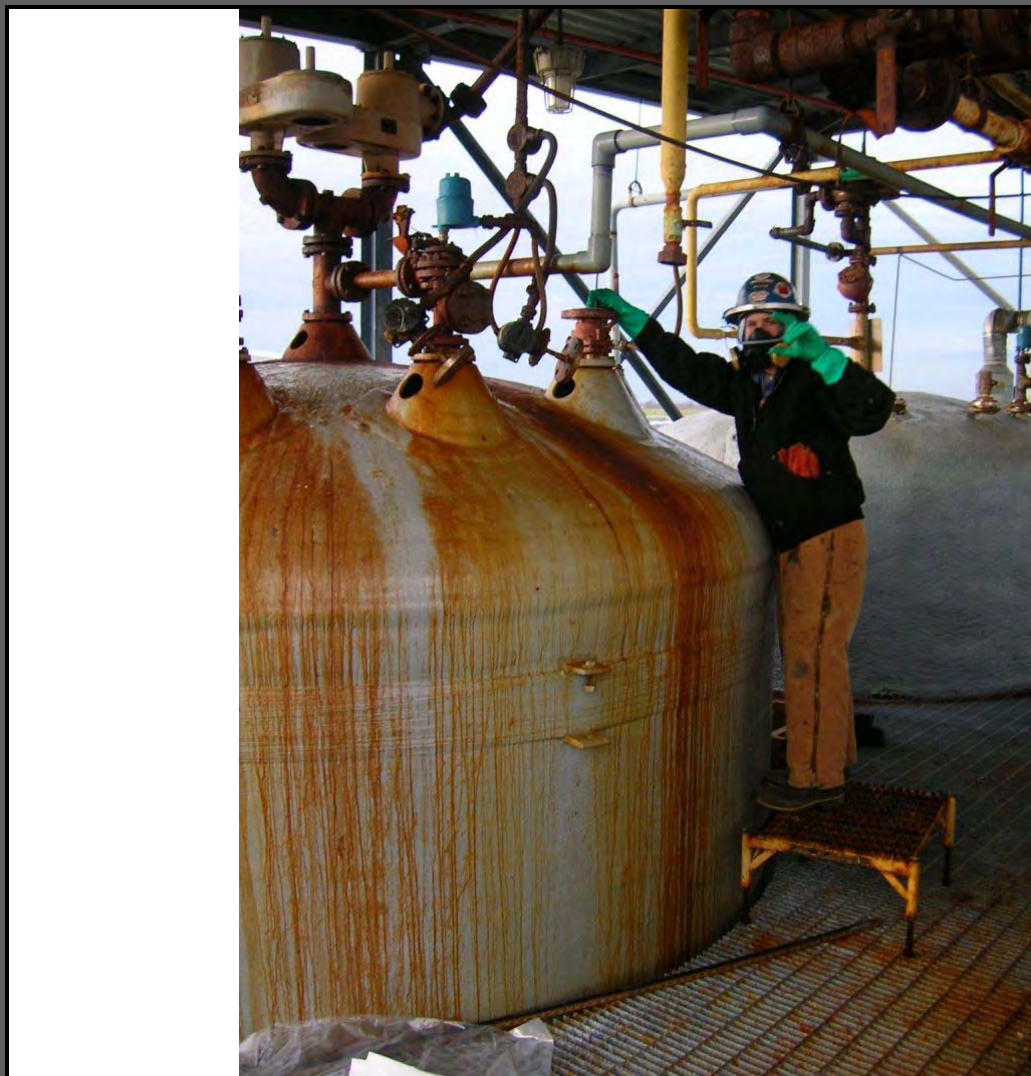
Logbook Photo #	068
US EPA ID / Task Order Number	ARR000005843 / TO-0001-08-01-01
Site	Diaz Intermediates Corporation
Location Address	301 Wyanoke Road
City, State, ZIP code	West Memphis, Arkansas 72301
County	Crittenden
Direction/Orientation	West-Southwest
Date	01/31/08
Time	0910
Photographer	Troy Naquin, Dynamac START-3
Witness	Charles Fisher, EPA Region 6
Description: ERRS gauging aboveground storage tanks.

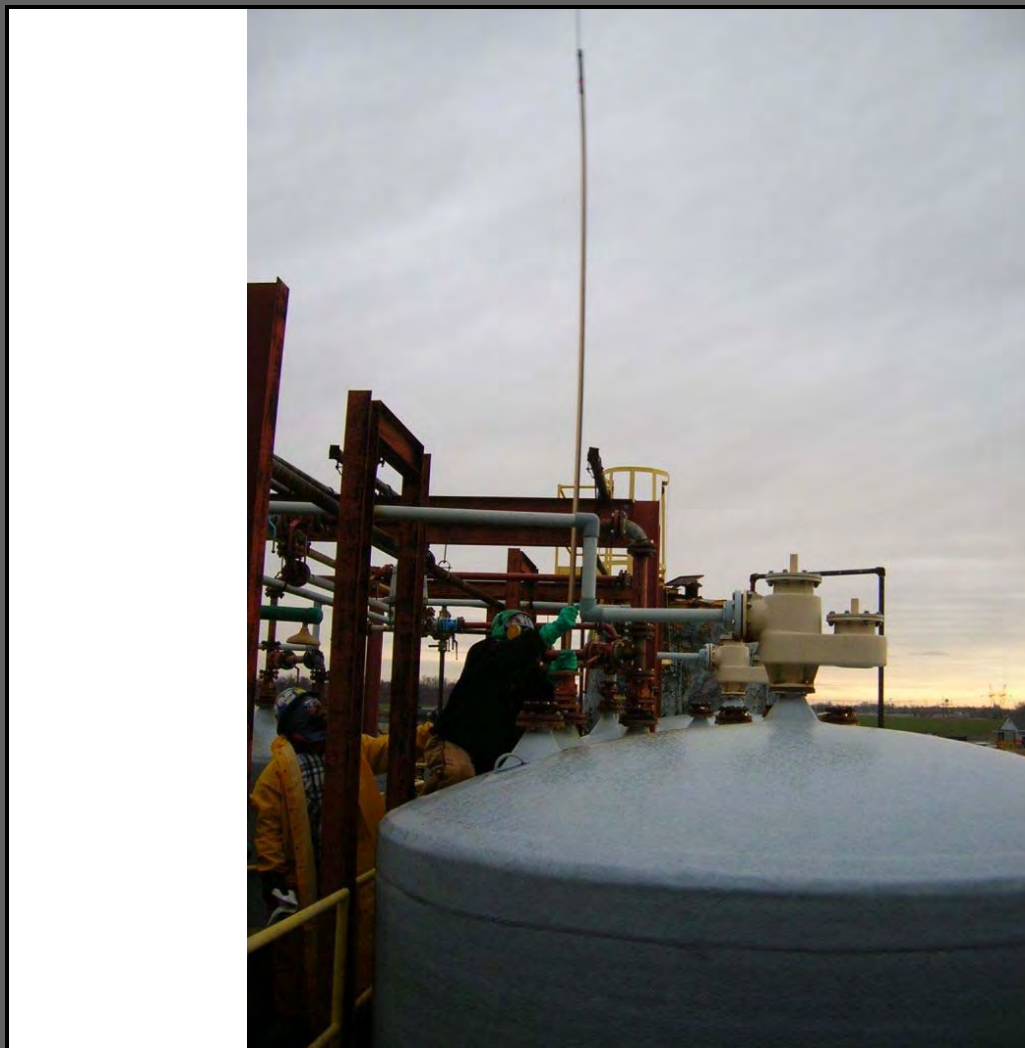
Logbook Photo #	069
US EPA ID / Task Order Number	ARR000005843 / TO-0001-08-01-01
Site	Diaz Intermediates Corporation
Location Address	301 Wyanoke Road
City, State, ZIP code	West Memphis, Arkansas 72301
County	Crittenden
Direction/Orientation	North
Date	01/31/08
Time	0930
Photographer	Troy Naquin, Dynamac START-3
Witness	Charles Fisher, EPA Region 6
Description: ERRS gauging aboveground storage tanks.

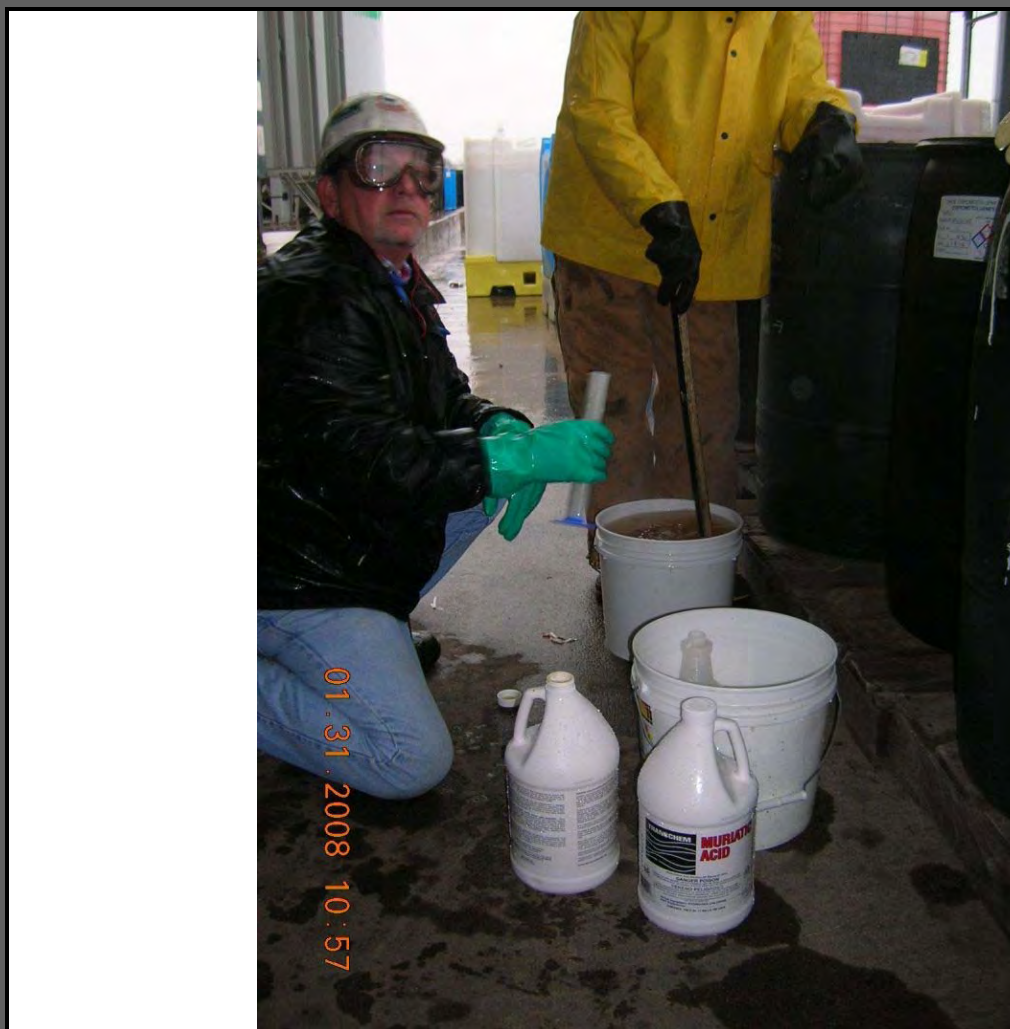
Logbook Photo #	070
US EPA ID / Task Order Number	ARR000005843 / TO-0001-08-01-01
Site	Diaz Intermediates Corporation
Location Address	301 Wyanoke Road
City, State, ZIP code	West Memphis, Arkansas 72301
County	Crittenden
Direction/Orientation	North
Date	01/31/08
Time	1057
Photographer	Troy Naquin, Dynamac START-3
Witness	Charles Fisher, EPA Region 6
Description: ERRS conducting bench scale study to determine how much muriatic acid is needed to precipitate out the zinc from the storm water in the Old Tank Farm secondary containment area.

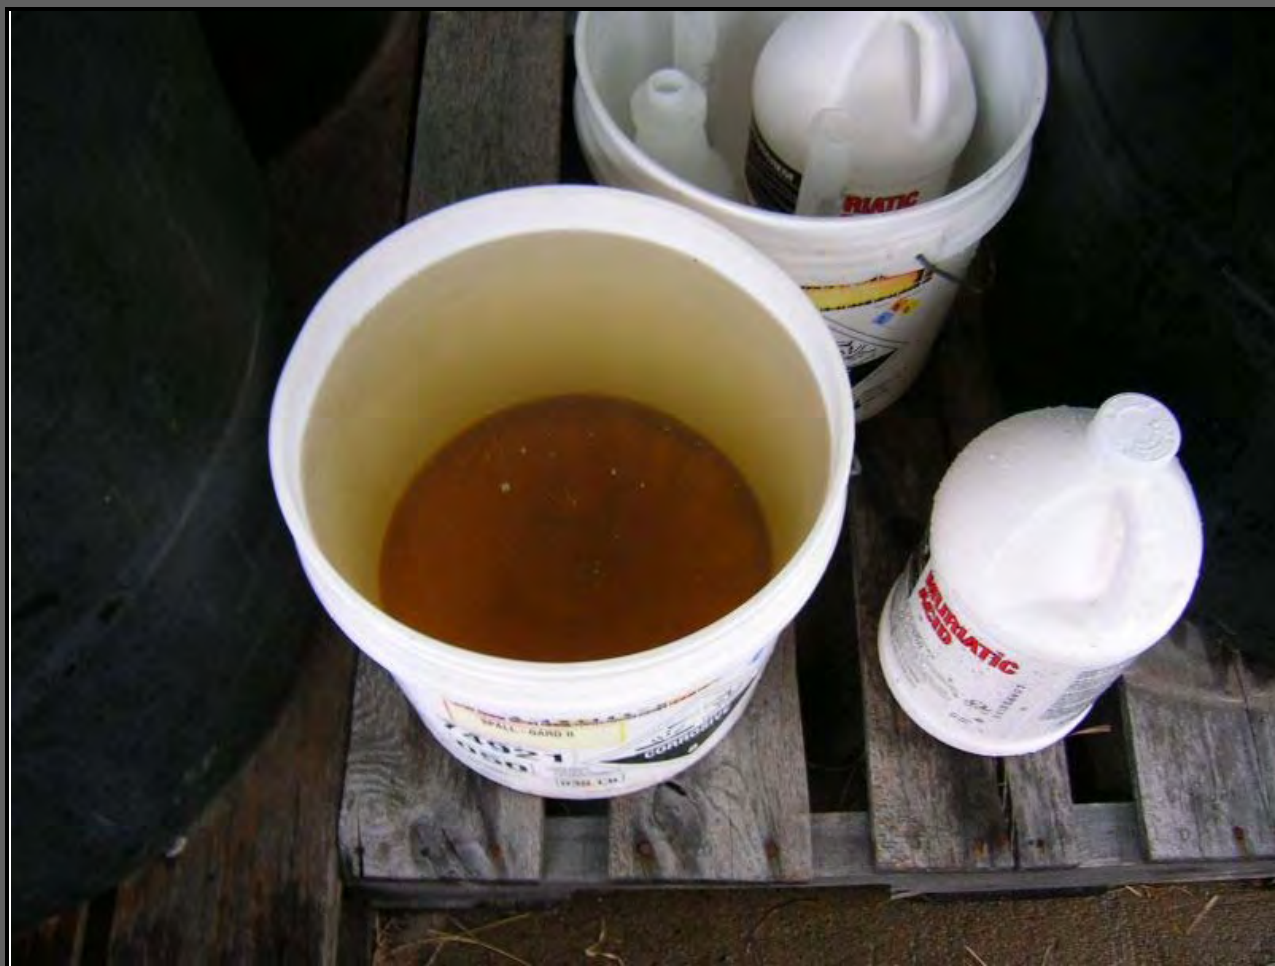
Logbook Photo #	071
US EPA ID / Task Order Number	ARR000005843 / TO-0001-08-01-01
Site	Diaz Intermediates Corporation
Location Address	301 Wyanoke Road
City, State, ZIP code	West Memphis, Arkansas 72301
County	Crittenden
Direction/Orientation	Down
Date	01/31/08
Time	1412
Photographer	Troy Naquin, Dynamac START-3
Witness	Charles Fisher, EPA Region 6
Description: Zinc precipitate at bottom of bucket.

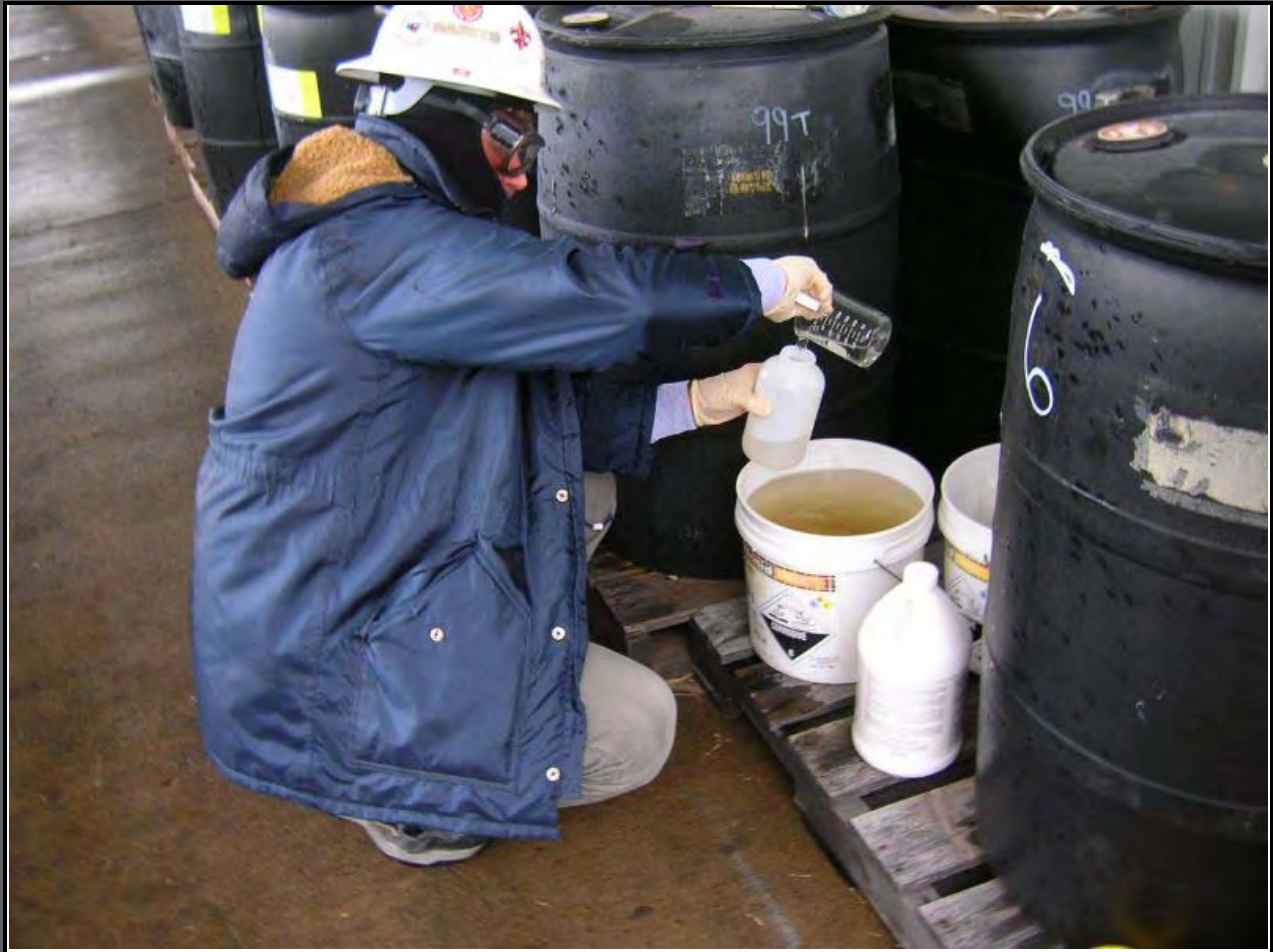
Logbook Photo #	072
US EPA ID / Task Order Number	ARR000005843 / TO-0001-08-01-01
Site	Diaz Intermediates Corporation
Location Address	301 Wyanoke Road
City, State, ZIP code	West Memphis, Arkansas 72301
County	Crittenden
Direction/Orientation	South-Southwest
Date	01/31/08
Time	1416
Photographer	Don Edgington, CET ERRS
Witness	Troy Naquin, Dynamac START-3
Description: START-3 collecting representative storm water sample from the Old Tank Farm secondary containment area, after treatment, for laboratory analysis.

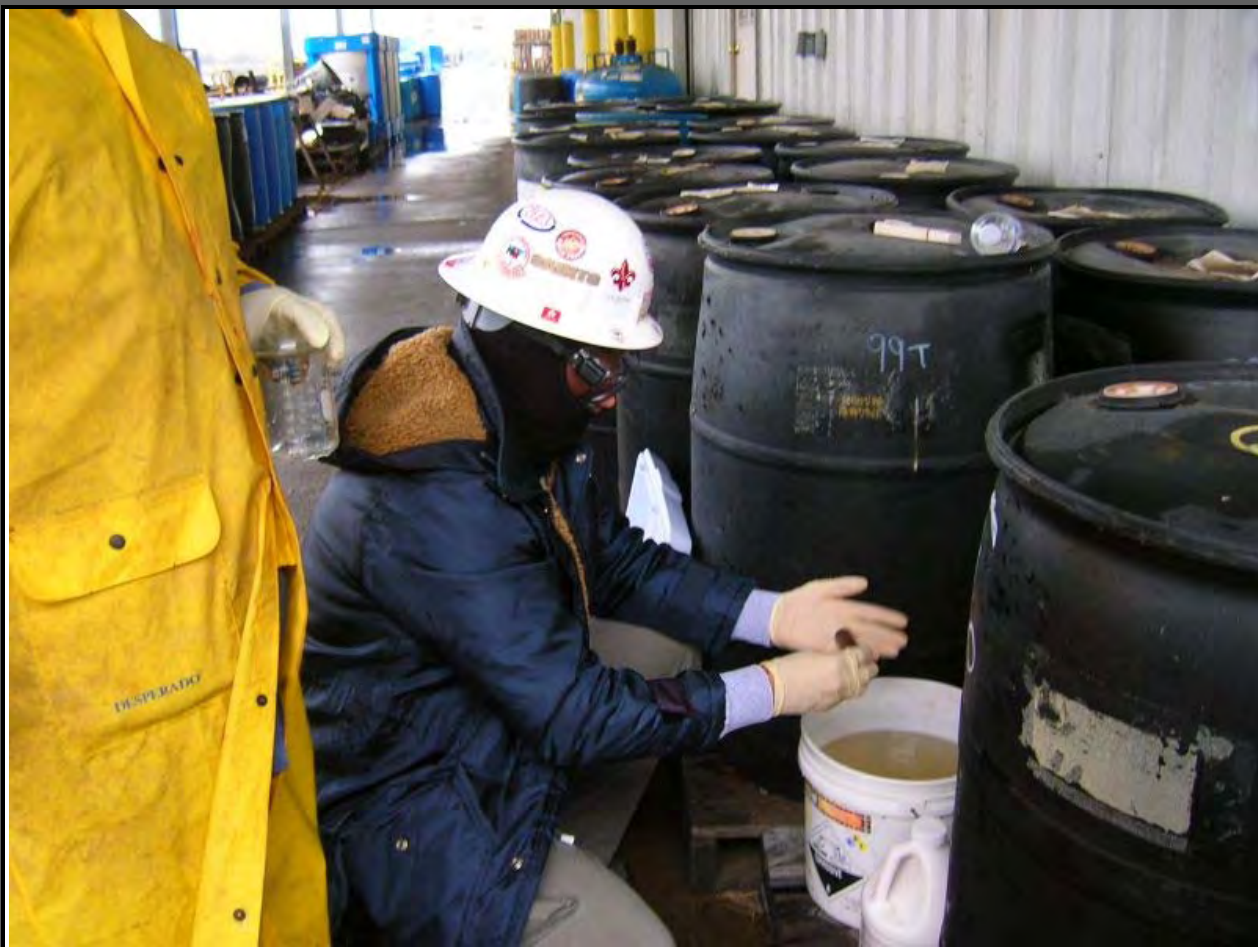
Logbook Photo #	073
US EPA ID / Task Order Number	ARR000005843 / TO-0001-08-01-01
Site	Diaz Intermediates Corporation
Location Address	301 Wyanoke Road
City, State, ZIP code	West Memphis, Arkansas 72301
County	Crittenden
Direction/Orientation	South-Southwest
Date	01/31/08
Time	1420
Photographer	Don Edgington, CET ERRS
Witness	Troy Naquin, Dynamac START-3
Description: START-3 collecting representative storm water sample from the Old Tank Farm secondary containment area, after treatment, to ship for laboratory analysis.
